Mechanism and Resolution of Implant Induced ESD Damage in GaAs IC Processing

Lam Luu-Henderson, Mehran Janani, John Bonk, Steve Canale, Mark Borek
Skyworks Solutions, Inc. 2427 Hillcrest Drive, Newbury Park, CA. 91320
Lam.Luu@Skyworksinc.com, (805) 480-4339

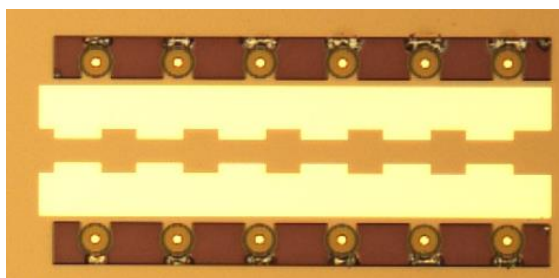
Typically, the isolation implant process is introduced early in the GaAs processing flow with no or very low density of metal contacts on the surface of the GaAs wafers. This is to avoid any potential yield impact caused by ESD damage as a result of the build-up of charge on the metal and wafer surface during the implant step. In circumstances where metal contacts are necessary prior to implant, the size and area of each contact must be minimized to prevent excessive ESD failures. A severe example of this occurred during a new HBT technology node development where the combination of ohmic metal contacts in an HBT array passivated by protective SiN_x (nitride) layer and coated with photo resist prior to implantation created the critical environment for the tremendous damage caused by electrostatic discharge. These ESD defects shown in Figure 1 contributed to both visual and probe failures and accounted for about 0.5% yield loss. The visual failure was captured by the inline optical (August tool) inspection and the probe yield loss was caught at the functional leakage test.

Figure 1. ESD defects on HBT transistor array

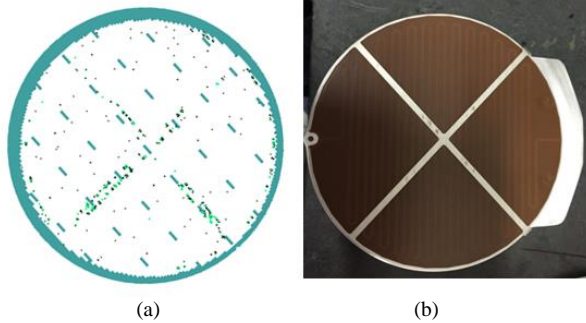
Figure 2(a) Yield map with cross-hair ESD failures (b) the Implanter ESC chuck ground path in a cross and ring pattern with the grounding pin to the left of the chuck.

The EATON/Axcelis 8250 implanter ESC chuck is uniquely designed for GaAs processing with the chuck divided into four equal quadrants so that the polarity of these sections can be reversed to allow for better release of the wafer after the implant process. The four sections of this ESC are laid out in a cross configuration within the outer edge ring as seen in Figure 2(b). The entire surface of the ESC is coated with an insulating polymer except for the cross-hair and outer ring areas which are used to ground the substrate through grounding pin as shown in the circular pinhole to the left of Figure 2(b).

During implant, the wafer is in constant contact with the grounding pin to ensure proper dissipation of the accrued charge. Throughout the implant process, positive $\text{He}^+/\text{He}^{++}$ ions are targeted at the wafer resulting in positive charges accumulating on the surface of the photoresist and conducting metal surface. However, these metal contacts are encapsulated by the nitride and photo resist films with no means for excess charges to dissipate. The only path for this charge build-up to be released is through the grounded and un-insulated cross pattern and outer ring of the ESC chuck. This naturally increases the concentration of charges on the wafer metal features along the cross pattern and outer ring areas resulting in higher probabilities of ESD damage in those regions. This failure mechanism is illustrated in Figure 3 and explains the locations of the yield loss as well as the numbers of finding from the experiments mentioned above.

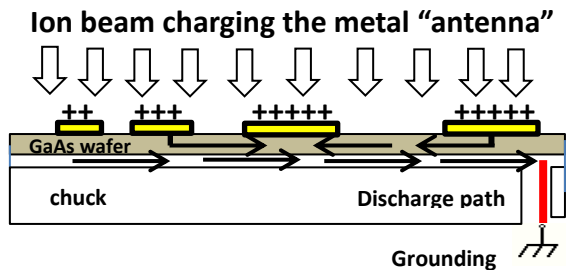
Figure 3. Illustration of the charge distribution across the wafer during implantation and the dissipation path through the grounded channels of the ESC chuck.

Specifically, this theory supports the observation that higher implant beam currents will result in higher amount of charge bombarding the wafer which then becomes congested around the grounding regions during implant and subsequently leads to higher ESD failures. In addition, this would suggest a direct relationship between the exposed metal surface area on the wafer during implant and the yield impact due to ESD damage. With ESD being dependent on the size of the contact area, this would account for the commonly observed defect map where the smaller, isolated transistors are unaffected by ESD while the larger arrays of HBT are more prone to the effects of electrical discharge as evidenced in the optical inspection yield map in Figure 4.

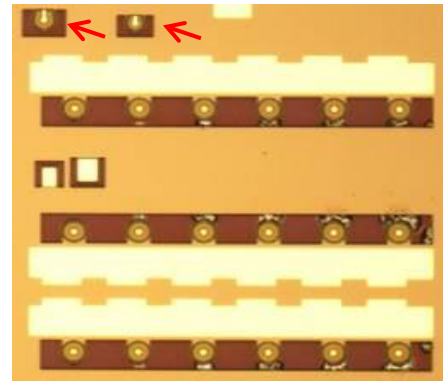
Figure 4. ESD defects on HBT transistor array and lone transistor without ESD failure.

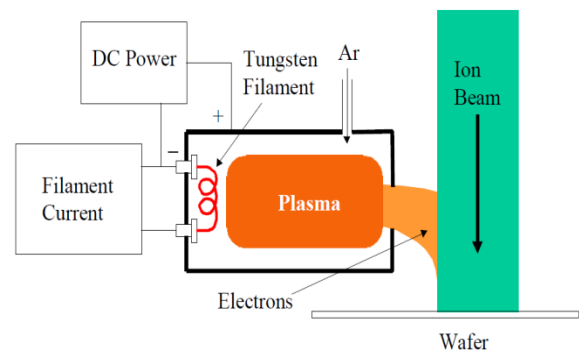
Figure 5. Diagram of the Implanter with E-Shower.

One industry-established method in addressing implant-related ESD damage is to incorporate an electron shower (E-shower) capability into the implant process [1]. This additional filament integrated into the hardware essentially floods the ion beam with a surge of negative charge that neutralizes the positive $\text{He}^+/\text{He}^{++}$ ions prior to implantation as displayed in Figure 5.

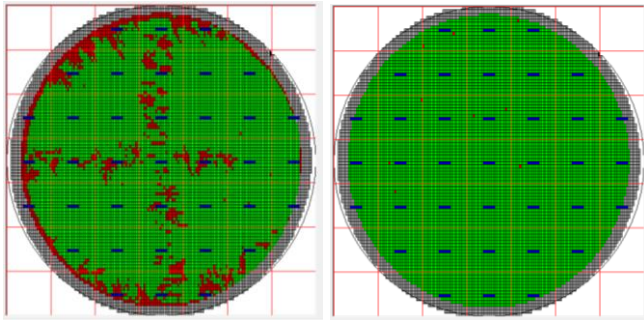
To simulate an extreme ESD-prone condition, GaAs wafers were deposited with contact metal then coated with a blanket sheet of photo resist followed by a coat of Silicon Nitride. These wafers were then implanted with and without the E-shower beam enabled and the results are displayed in Figure 5. Wafer processed with E-shower showed no symptom of ESD in comparison to the non E-shower wafer exhibiting an extreme case of ESD damage.

Figure 6. Yield maps of wafers without and with E-Shower during implant.

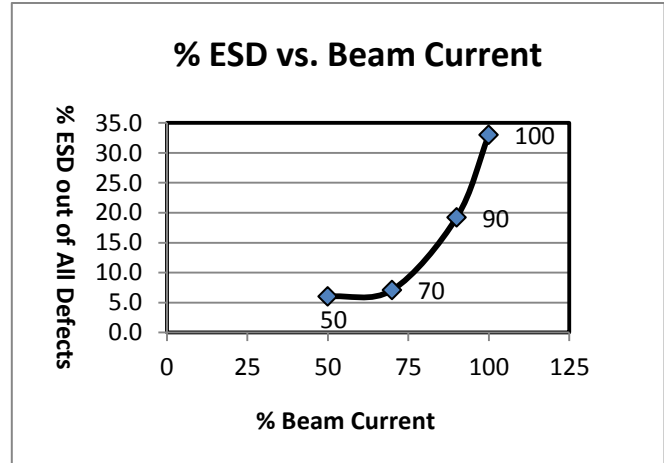
correlation between the beam setting and the amount of ESD loss. The degree of charging on the wafer as a function of the implant current was thoroughly studied by the EATON Corporation which first developed the E-shower capability back in the 1980's [1].

Figure 7. Plot of the % ESD damage out of all visual defects versus the implanter beam current for a given isolation recipe.

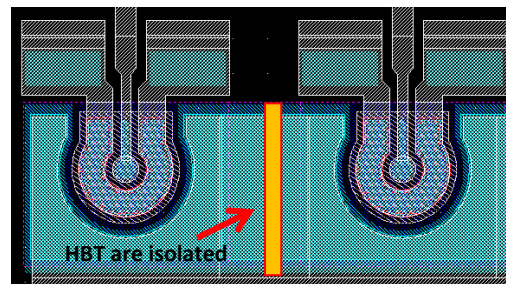
Figure 8. Layout showing the HBT segments are disconnected which help reduce charge buildup along the metal surface.

Another potential solution, although at times challenging is to redesign the layout of the device structures to isolate them electrically, keeping the overall surface area to a minimum and reducing the probability of charge build up on metal contacts which in turn can result in ESD. An example for this layout is showed in Figure 8 in which the transistors in the array are disconnected electrically and with smaller conducting surfaces, will acquire less charge and therefore less opportunities of an electrical discharge. This change can be implemented through etch, isolation process or altering the subsequent interconnecting metal.

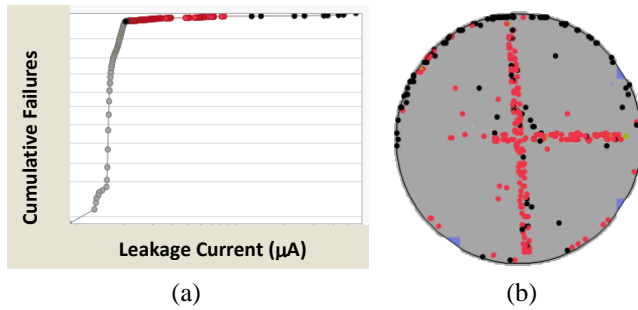
have gone undetected. This test involved increasing the bias voltage in order to catch marginal or leaky dies. The failures uncovered by this method were later confirmed to be ESD induced which proved that this test is a good filter for this type of defects. Figure 9 depicts the leakage failure and resulting failed dies which again followed the cross and outer ring pattern consistent with the implant ESD damage.

Figure 9(a) Example of extra leakage test detecting ESD failures (b) Yield map showing failed dies in the cross and ring pattern.

Finally, to further prevent additional escapes, a combination of visual inspection and probe test were implemented. Particularly, 100% final outgoing August inspection was used to screen out visual ESD failures while a special leakage test was applied to the standard functional probe test in order to catch any weakened die that might
