# Minimizing implant-induced damage in GaAs ICs

Introducing an electron-shower current in an ion-implanter eliminates charge-induced damage in GaAs epiwafers

**BY LAM LUU-HENDERSON, SHIBAN TIKU, MEHRAN JANANI, JOHN BONK, STEVE CANALE AND MARK BOREK FROM SKYWORKS SOLUTIONS**

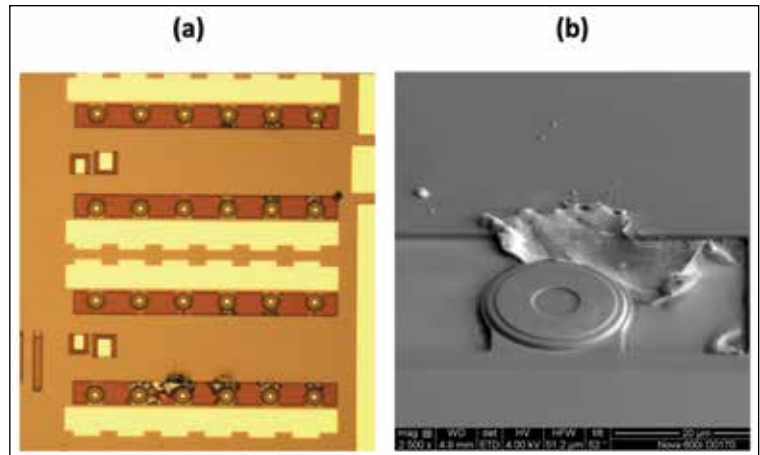
Figure 1. (a) Electrical charging defects on a pilot lot for a Skyworks HBT transistor array (b) Scanning electron microscopy image of the charging damage to the HBT structure

Several steps have been re-arranged during the development of our latest HBT process. During our evaluation of pilot lots, we observed several defects caused by severe electrical charging damage (see Figure 1). These charging-induced, blown-out defects contributed to visual and probe failures, and accounted for an overall yield loss of about 0.5 percent. Our inline automatic optical inspection tool uncovered visual defects, while functional leakage failure exposed the probe yield loss.

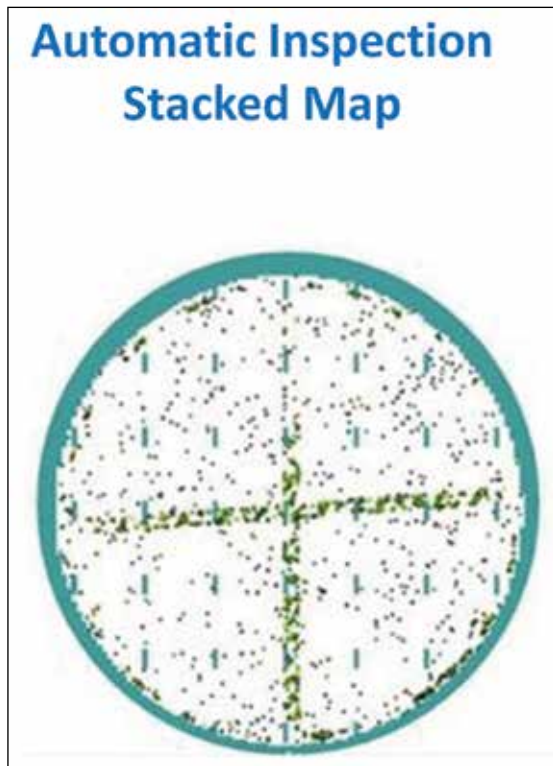
Figure 2. Stacked automatic inspection maps of damaged die, exposing a cross-hair and outer ring pattern with electrical discharge failures.

Initially, we thought that our blown and melted features, which we discovered by inline visual inspection, were distributed in a fairly random manner across the wafers. But when we stacked up the inspection yield maps, we found a very distinct cross and outer ring pattern (see Figure 2).

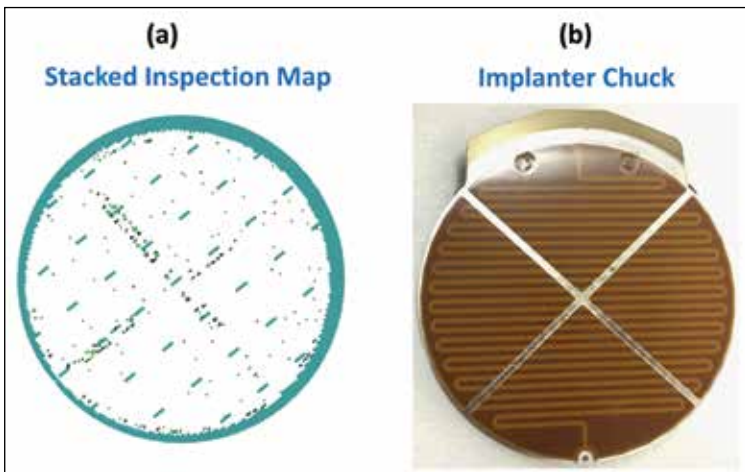
Figure 3. (a) The yield map of damaged die reveals a cross-hair pattern of electrical charging failures (b) In the Axcelis 8250 ion implanter, the electrostatic chuck ground path is in a cross and ring pattern, with the grounding pin to the left of the chuck.

implantation is the source of the defect. The ‘smoking gun’ is a damage pattern that resembles the features of the cross and outer ring of our implanter wafer station, which uses an electrostatic chuck (see Figure 3).

are the only locations directly connected to ground through a grounding pin (see Figure 3(b)).

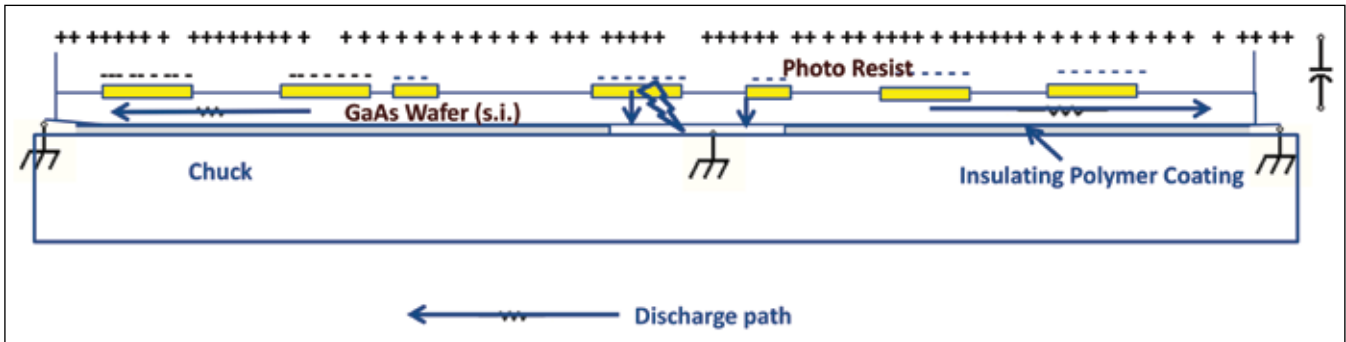
Figure 4. An illustration of the charge distribution across the wafer during implantation and the dissipation path through the grounded channels of the electrostatic chuck.

If they are exposed, the metal features on the wafer act as antennae; and if they are covered by photoresist, they charge up like capacitors – depending on position, size and shape – until the voltage builds to a critical level, followed by a fast discharge to ground (see Figure 4 for an illustration of this failure mechanism). Note that the path of

resistance depends on the position on the chuck, and is lowest in the cross and ring.

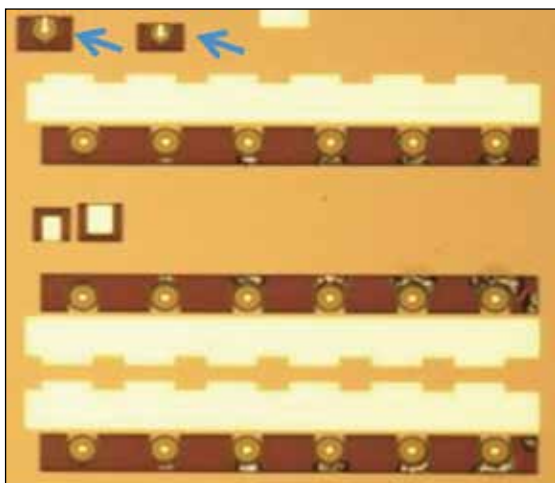
Figure 5. Electrical discharge induces damage on HBT transistor array, but the lone transistors are defect-free.

Our explanation for the cause of wafer damage is consistent with the finding that the frequency of failures depends on the surface area. When metal contacts are larger, they will attract and accrue more charges, leading to even greater arcing effects. This is evident in optical images, where the smaller, isolated

transistors are unaffected, while larger arrays of HBTs are more prone to the effects of electrical discharge (see Figure 5).

One way to comply with these rules is to configure the transistor collector contacts in the array so that they are just segmented electrically (see Figure 5). This ensures that each contact has a smaller conducting surface. Joining the contact areas together with an interconnect metal, deposited after the ion-implant step, trims charge build-up and reduces the likelihood of arcing-related events.

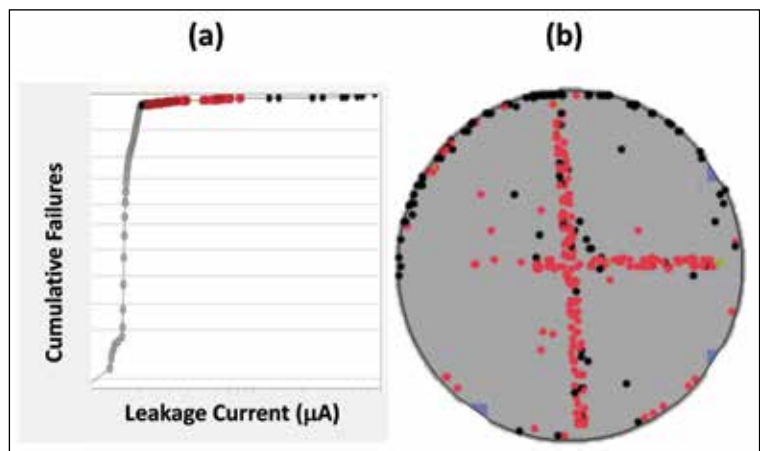
Figure 6 (a) Example of a leakage test detecting electrostatic damage failures. (b) A yield map showing failed dies in a cross and ring pattern.

To effectively identify these discharge failures, we have employed two modes of detection: automatic optical inspection, first after the implant step and again at the final outgoing die inspection; and a leakage probe test. The latter employs tighter limits to catch electrically weakened die that threaten to go undetected by automatic optical inspection and could potentially result in escapes. To identify these marginal and leaky die, we increased the bias voltage (see Figure 6 for the results of this approach).

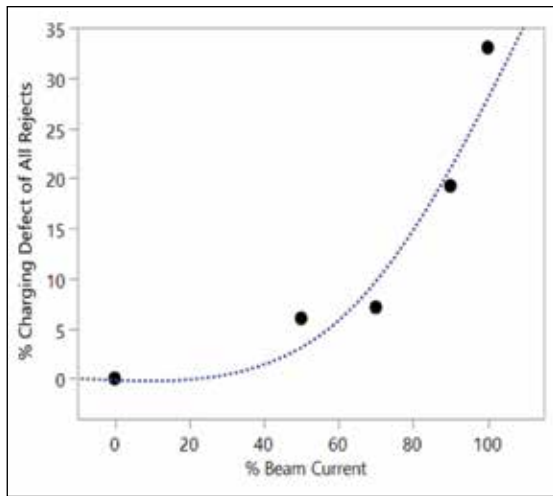
Figure 7. Charging induced defects increase as the implanter beam current rises.

As the beam current is cranked up, there is an increase in charge accumulation on the wafer. This results in current crowding around the grounding regions during implant, and subsequently increases the number of higher electrical-discharge failures. As expected, there is a direct correlation between the magnitude of the beam current and the extent of the charging damage.

To put this theory to the test, we varied the implant beam current from 0 percent to 100 percent, before immediately scrutinising implanted wafers with automatic optical inspection. After comparing the number of charging-induced failures with the total for detected defects, we observed a strong correlation between the beam current and the amount of charging damage.

We live in an era of lean manufacturing, where it is often unfeasible to modify hardware for defects occurring at a level of parts per million. In these circumstances, alternative approaches are required to mitigate and contain these types of yield loss. One option is to dial back the implant beam current to limit the rate at which the ions hit the wafer. Ultimately, this decreases the charge collected at the contact metal, and should diminish the level of damage (see Figure 7).

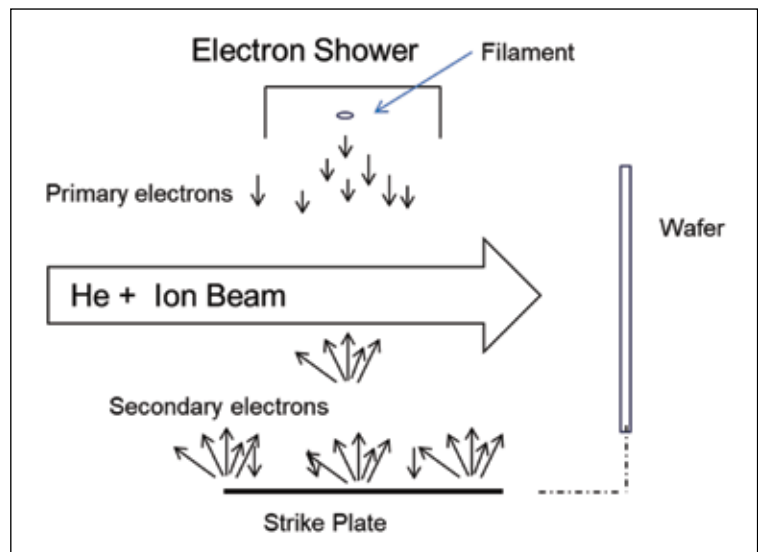
Figure 8. Charge-induced defects fall with the introduction of an electron shower into the end station, which features a single filament configuration. The strike plate is made of graphite to avoid contamination to GaAs circuits.

In the case of our Axcelis NV8250 ion implanter, the electron-shower is integrated into the end station, where the wafer is staged for implantation. Using this design, electrons from the emitting filament flood the ion beam with a surge of negative charge, neutralizing positive He<sup>+</sup> and He<sup>++</sup> ions prior to implantation (see Figure 8).

With our tool, the electrostatic chuck holds the wafer horizontally prior to implant. However, once the ion beam is optimized for implantation, this chuck end-station moves to an upright position. As primary electrons hit the strike plate, secondary electrons are generated, ensuring that positive charge has no chance of building up. In addition, secondary electrons are generated when the beam hits the wafer surface (see Figure 8).

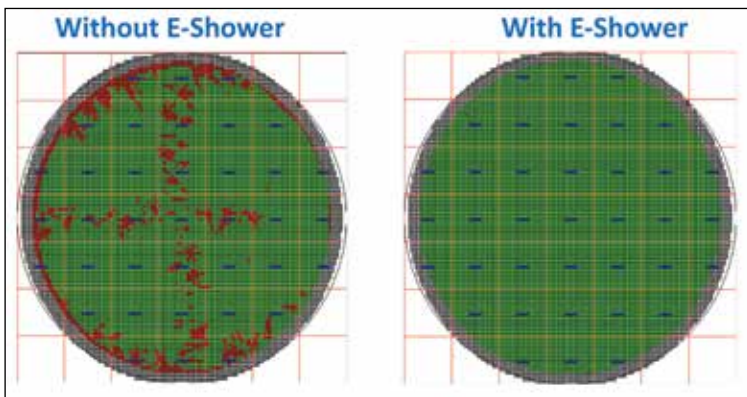
of wafer were implanted with and without an electron-shower beam. Experiments revealed that wafers processed with an electron-shower were free from charging symptoms, while those without an electron shower exhibited a severe case of discharge damage (see Figure 9).

Figure 9. Yield maps of wafers with and without electron-shower during isolation implant.

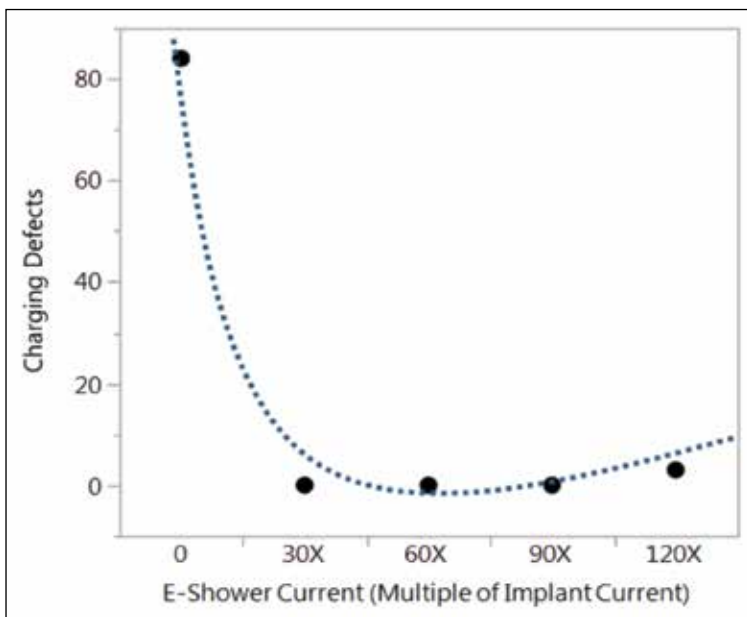
Figure 10. The charging-induced defect percentage as a function of electron-shower primary beam current, for a given implant recipe.

It is recommended that the electron-shower primary current should be around thirty times the implant beam current. We have put this figure to the test, finding that even when the current is increased well beyond this recommended value, there is still zero to negligible implant charging-induced defects (see Figure 10). In other words, there is a very broad process window for using the Axcelis NV8250, while realizing an extremely low probability of negative charging.
